Patterns and mechanisms of repeat drainages of glacier-dammed Dañ Zhùr (Donjek) Lake, Yukon

Dañ Zhùr (Donjek) Glacier is a surge-type glacier that undergoes cyclical periods of rapid advance over ~1–2 years, followed by retreat for ~10 years. Since the 1990s, the advances have caused the formation of ice-dammed Dañ Zhùr Lake, which has filled and drained in summers following a surge event. Here, we report how these drainages initially occur through a subglacial channel under the glacier terminus, which then typically closes the following winter, enabling another lake to form and drain the next summer. However, our remote sensing and field observations indicate that after several drainage events, a subaerial ice canyon is formed through the glacier terminus, which prevents another lake from forming until after the glacier surges again. We predict that the next surge of Dañ Zhùr Glacier will occur around the mid-2020s, causing the formation of a larger Dañ Zhùr Lake during the following quiescent phase because, despite periodic advances, a long-term trend of glacier recession is exposing a larger basin for the lake to form in. However, each subsequent surge is causing less terminus

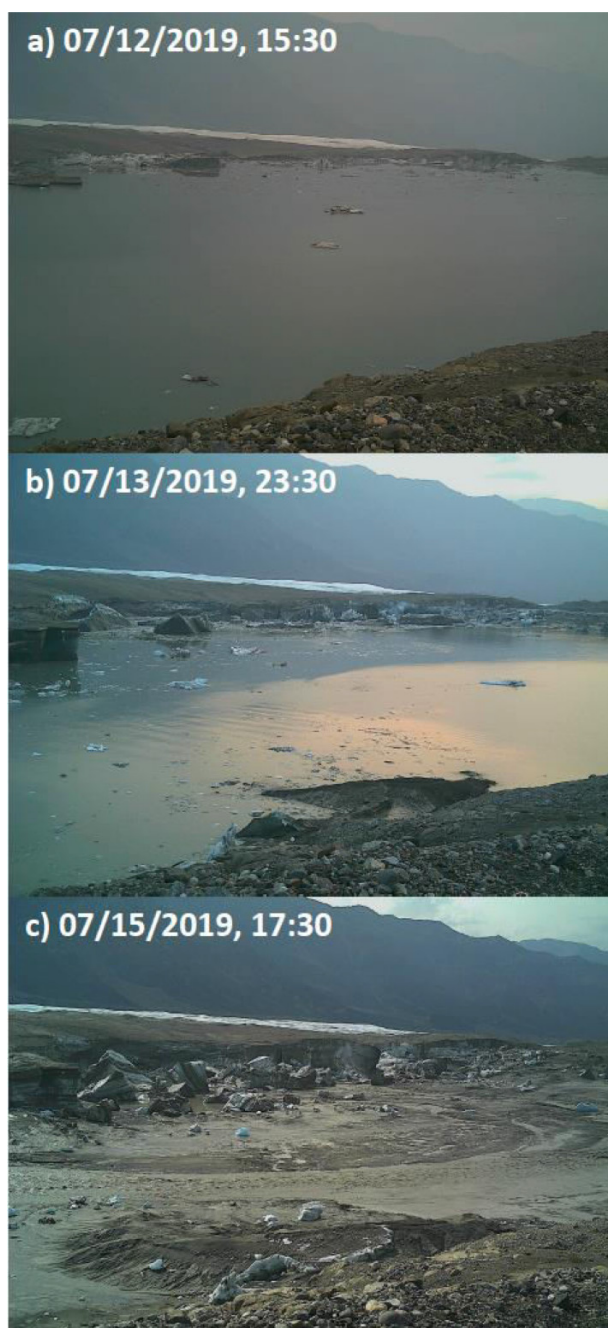
Fig. 4. Images from the timelapse camera (see viewshed in Fig. 1) showing before, during, and after 2019 lake drainage: (a) July 12, 15:30; (b) July 13, 23:30; and (c) July 15, 17:30. All times are in local Pacific Standard Time (PST) (GMT-8). For scale, it is approximately 1 km from the camera to the edge of the glacier.

We also captured the 2019 drainage event using a SpyPoint solar trail camera, which was installed on 12 July 2019 on a small tripod securely mounted on bedrock, and recorded images hourly. The camera overlooked the lake and terminus of Dañ Zhùr Glacier (Figs. 1 and 4), including the location where the lake drained.

The timelapse camera and pressure transducer provide a detailed timeline of lake levels during the 2019 lake drainage event (Figs. 4 and 5). These instruments show that drainage started at 17:30 PST on 12 July 2019 and continued until about noon on 15 July 2019.

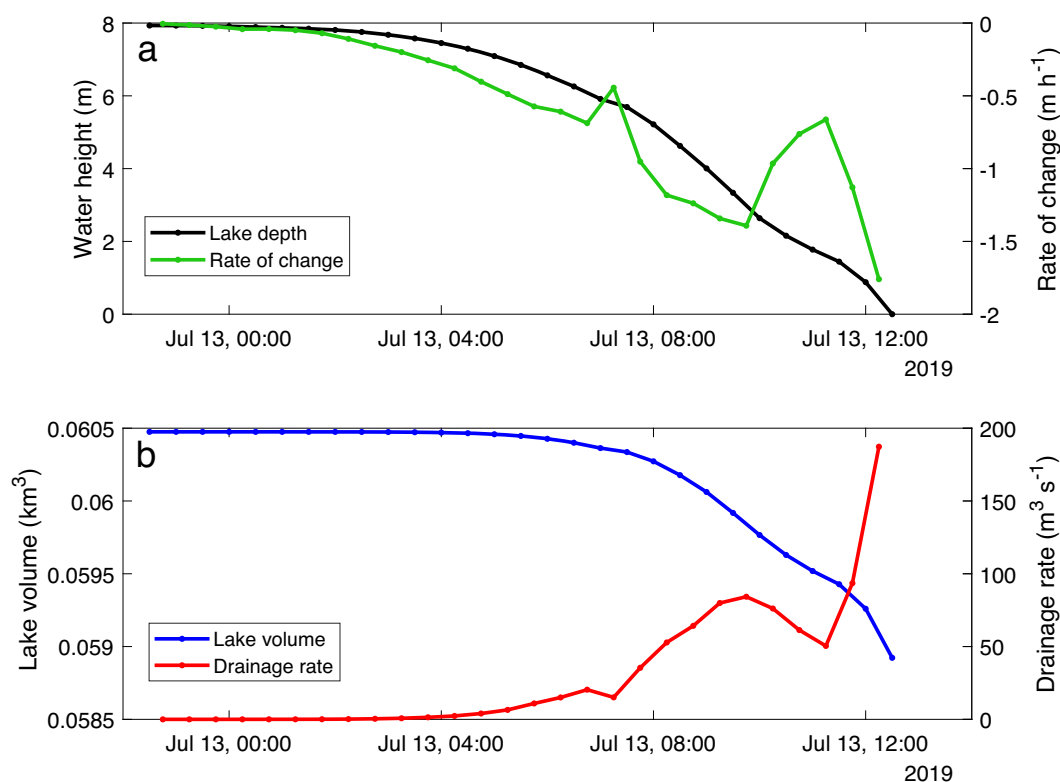
Fig. 5. (a) Pressure transducer record showing water depth and hourly rate of change at the start of the drainage of Dañ Zhùr Lake, 13 July 2019. (b) Volume and drainage rate of Dañ Zhùr Lake, computed from the pressure transducer record and the empty lake DEM from September 2019. All times are local PST (GMT-8).

The pressure logger recorded an initial lake level change rate of less than -0.10 m h^{-1} from 17:30 PST until 23:30 PST on 12 July, after which the lake began to drain faster (Fig. 5a). The lowering rate continued to accelerate until $\sim 09:30$ PST on 13 July when there was a reduction in the rate of change until 11:00. Lake drainage then accelerated rapidly to reach a peak lake level change of -1.76 m h^{-1} at 12:00, equating to a drainage rate of almost $200 \text{ m}^3 \text{ s}^{-1}$ (Fig. 5b). Soon thereafter the sensor was exposed to the atmosphere, but the lake continued to drain as the transducer was not at the bottom of the lake. The timelapse camera shows that the lake was completely drained by 12:00 PST on 15 July 2019.

0.0016 km³ (16 000 000 m³) of lake volume was drained downstream (Fig. 5b). The reduction in drainage rate during this period may be linked to growth of the subglacial channel and (or) change in the efficiency of the subglacial flow as the lake level dropped back to below ice flotation level. We are unable to calculate the temporal change in drainage rate once the pressure transducer was exposed, but based on a remaining drainage time of 47.5 h and remaining lake volume of 0.0589 km³, the average drainage rate for the rest of lake emptying was ~345 m³ s⁻¹.

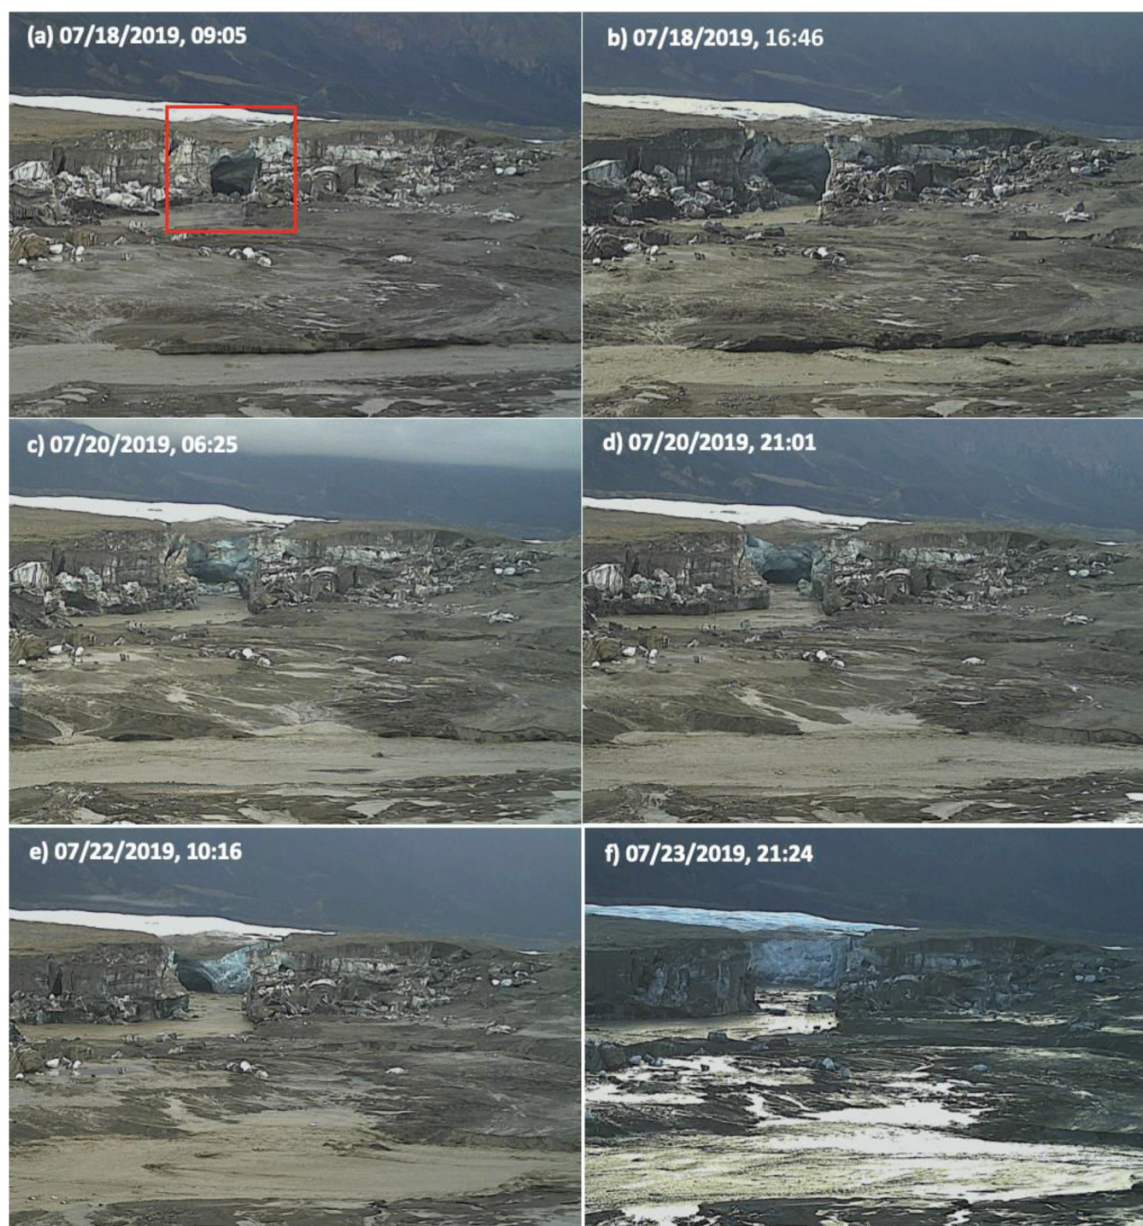
Fig. 7. Timelapse camera photos of the development of the ice canyon at the terminus after the 2019 drainage event. Red box indicates canyon location. All times are local PST (GMT-8).

Satellite imagery and the timelapse camera show that on 16 July 2019, the roof of the new channel was still present. On 18 July, some subsidence and collapse of the roof occurred near the channel entrance (Figs. 7a and 7b), as indicated by expanding crevasses on either side. The canyon continued to grow over the following days (Figs. 7c, 7d, and 7e), until the roof completely collapsed on 23 July (Fig. 7f).
